SB, CLUTCH DRUM, K760, K760 C-n-B, 2017-11

SYMPTOM/DESCRIPTION

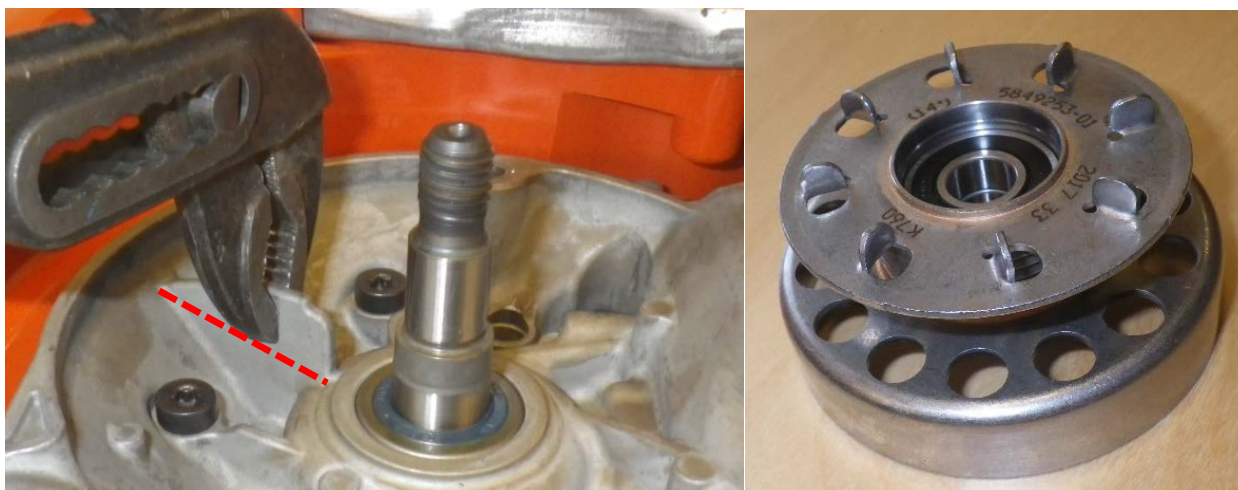
The clutch drum is not backwards compatible without a small re-work of the crankcase:

- The fin that has been used for guiding the belt needs to be removed.
- Use a pair of pliers or a monkey wrench and break the fin along the dashed red line.
